# CONCREEP 10

PROCEEDINGS OF THE 10TH INTERNATIONAL CONFERENCE  
ON MECHANICS AND PHYSICS OF CREEP, SHRINKAGE, AND  
DURABILITY OF CONCRETE AND CONCRETE STRUCTURES

## Delayed Shear Crack Formation of Shallow RC Box Culverts in Service

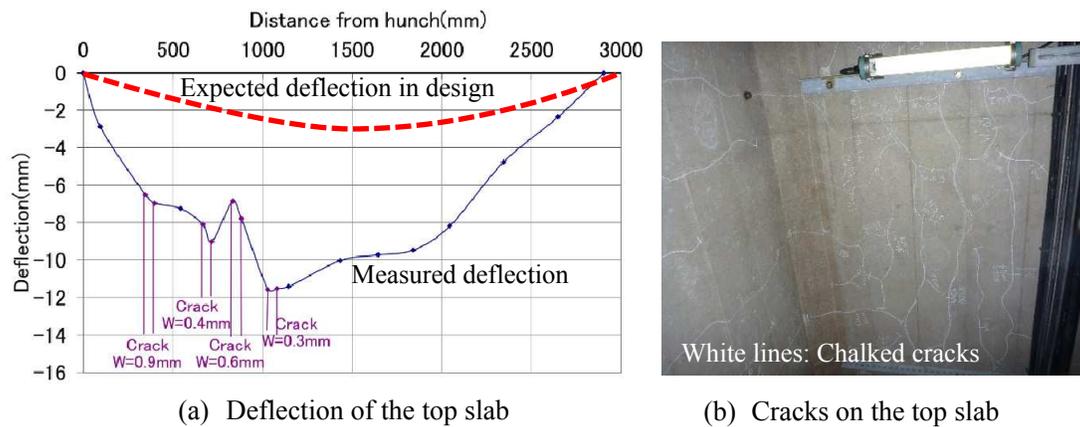
Kunieda et.al (2014) reported that top slabs of shallow underground RC box culverts were seriously deformed with numerous cracking. After a few decades of service, the deflection of the top slab exceeded approximately 3 to 10 times the design prediction by the conventional codes for practice as shown in Figure 1(a). Large numbers of cracks at the inner surfaces of tunnel have also been observed as shown in Figure 1(b). The largest crack width near the haunch is 0.9mm, which is more than three times the allowable value specified (Standard Specifications for Concrete Structures – 2007 (2007)). Through the analytical approach in consideration of migration of moisture and associated shrinkage, the authors reported that long-term excessive

Figure 1 Excessive deflection and cracks of the culvert

deformation may attribute to synergy effects accompanying delayed shear failure owing to the vertical soil pressure, which can be accelerated by shrinkage and creep of structural concrete.

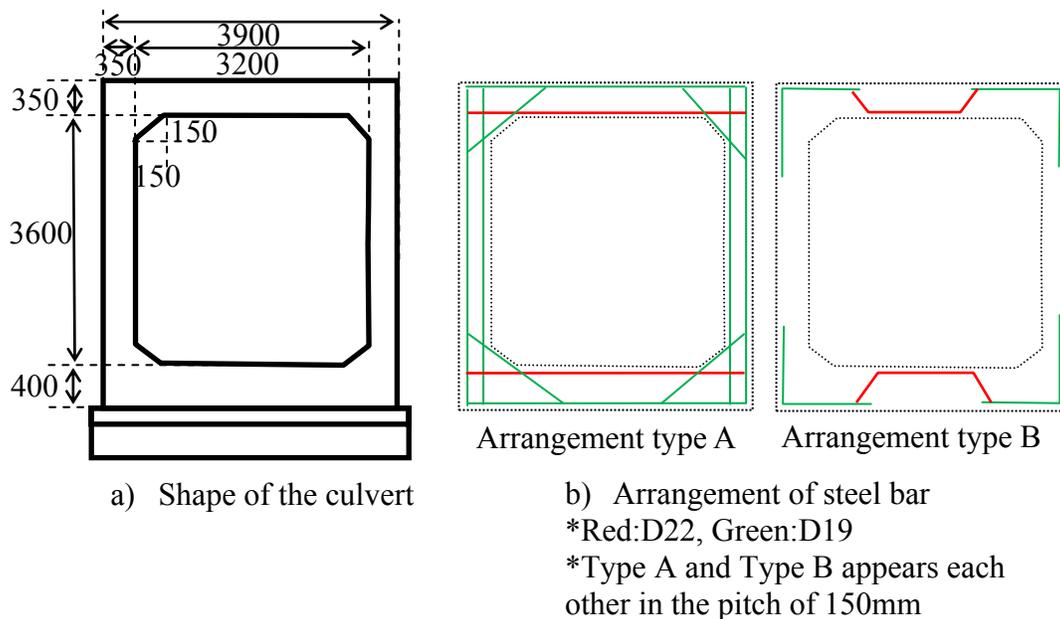
The dimensioning and detailing of the tunnel section suffering from excessive deflection are shown in Figure 2. This culvert was constructed in 1982. The thickness of the top slab is 35cm and the height of the fill above the culvert is relatively low, ranging from 5.04m to 6.98m. The dry sand is used as for backfilling material. This culvert has been used for urban utility and cabling, and it is in service as well. In order to keep the stable local ambient conditions, air ventilation is conducted with blower fan machines, and the temperature is kept about  $25 \pm 2$  degree Celsius. Then, the internal surfaces of the culvert have been exposed to continuous drying ( $RH=30 \pm 10\%$ ). The outer surface exposed to soil foundation was kept almost wet during its whole life and the ground water level is about at half of the side walls. It is

Figure 2 Design detail of the culvert

observed by the periodical monitoring that the number of cracks in the culvert has been increasing and the crack width has also become wider with time. Some cracks have reached reinforcing bars, but the steel corrosion is not observed at this moment because of less supply of moisture due to dry states. As a matter of fact, water leakage was found at several locations inside the culvert, but they are not from the top slab but the side walls and construction joints.

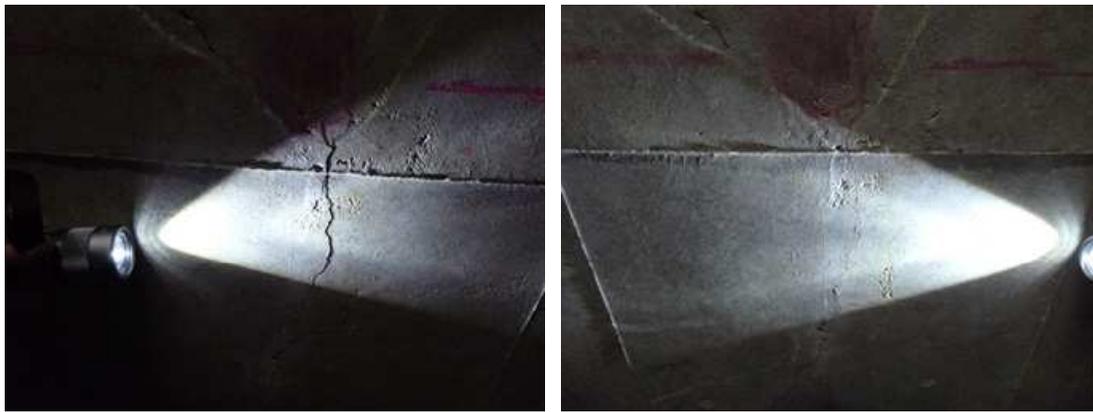
(a) Light from the span center (b) Light from the hunch side  
 → Same crack is shoot, but shade appears only in (a) because of the gap.

Figure 3 Transverse gap on the crack in the top slab

out-of-plane deformation of cracked concrete as shown in Figure 3. This gap was observed larger near the hunch side where the greater shear force is thought to be applied than the center span. Then, this crack is highly estimated to be an extreme end of diagonal crack planes.

This transverse gap can be easily detected as well by shadows of the skew illumination as shown in Figure 3. In the case of flexural cracks without the transverse gap, no shadow is made no matter how much directions the illumination is applied. This is some sort of visual inspection to detect the out-of-plane alone.

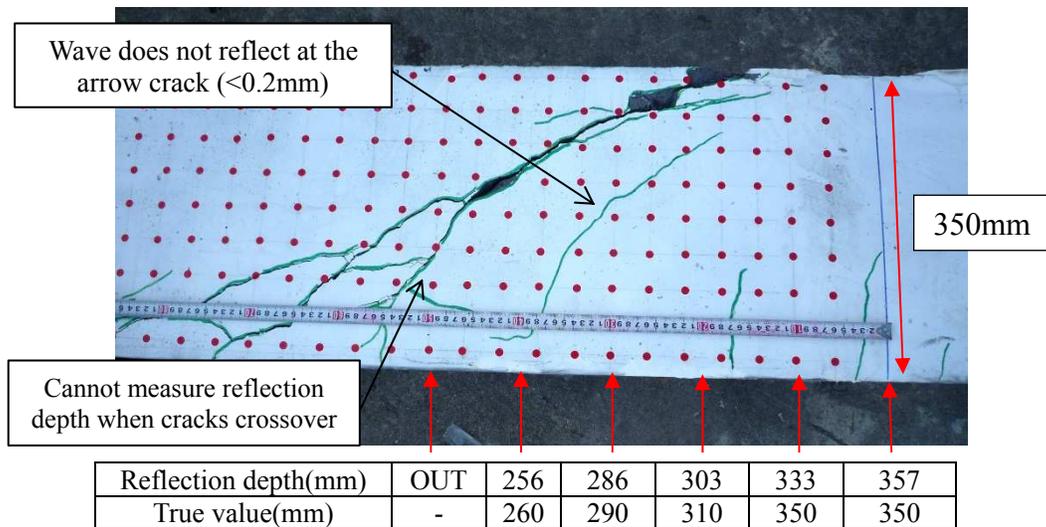
Figure 4 Verification of the elastic wave reflection test

The elastic wave reflection test (e.g. Schabowicz et al. (2012)) was also conducted at several points on the line normal to the culvert axis. If the crack is vertical bending one, the acoustic wave should reflect at about 350mm depth (opposite side of the slab thickness). But, if the crack would be inclined to the centroid axis of the slab, the reflecting depth will be smaller. Validity of the method was examined in advance by using the beam which failed in the mode of shear. Figure 4 shows the depth of wave reflection point which agrees well with the crack depth from the bottom side of the beam.

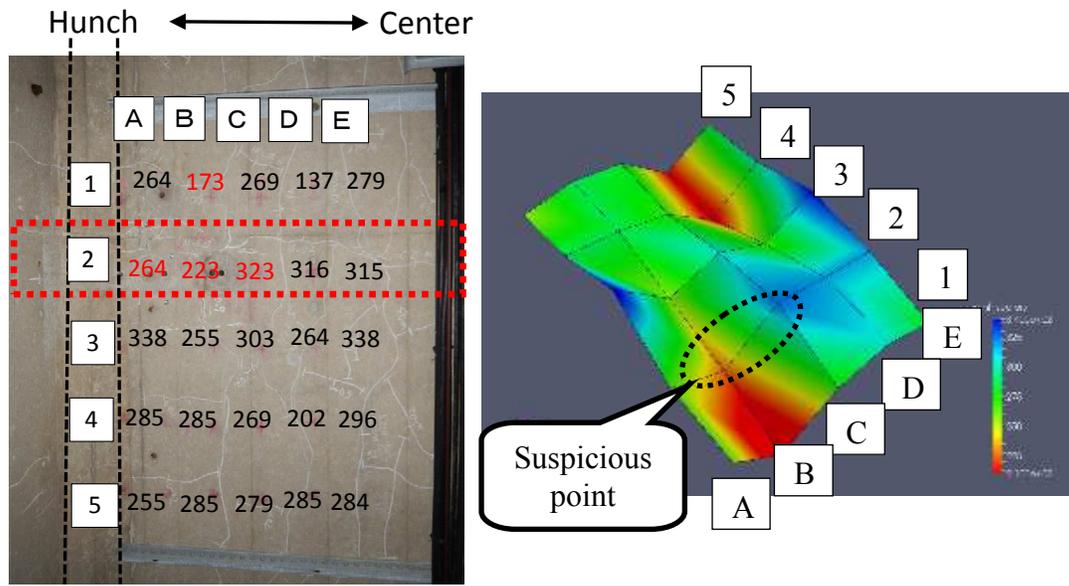
Figure 5 Contour map of the wave reflection depth in the culvert

Figure 5 is the detected height map of the wave reflection depth in the culvert, and it is found that there exist some points where the wave reflection changes significantly around the point. At these points, diagonal shear crack is suspected to be present. Around the most suspicious point between 2-B to 2-C as shown in Figure 5, several micro-bore holes were drilled in about 300mm depth, and the inner surfaces were scanned by the stick scanner (Zacoeb et al. (2007)). The scanned images are shown in Figure 6, and a crack across the hole is found from this image. The enclosed shape of the crack plane is expected from the depth where the crack intersects the hole. This seems to be a typical diagonal shear crack, and it does not reach the flexural compression zone.

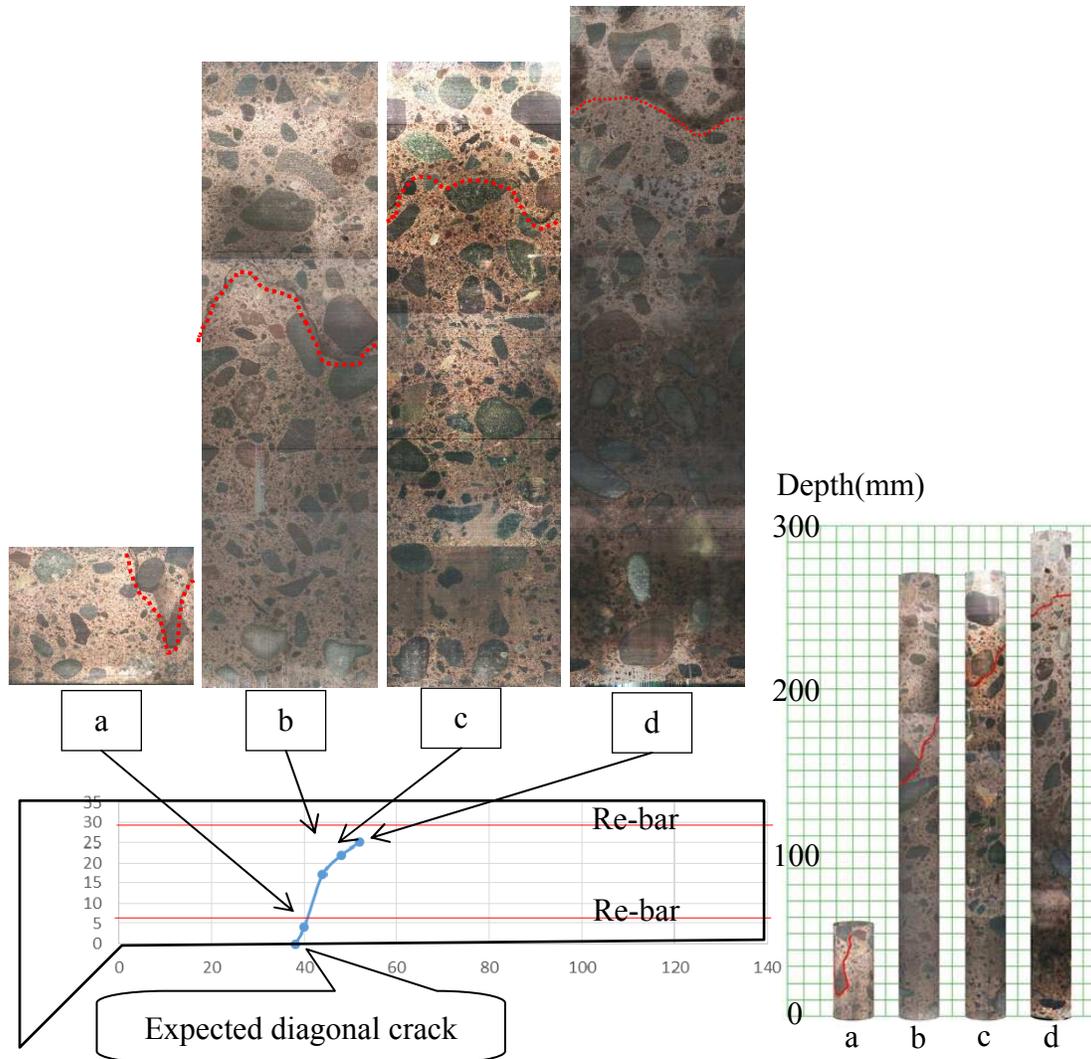
Figure 6 Image of the inner surface of the hole and expected diagonal shear crack in the top slab

With these observations, it can be concluded that the excessive deflection is caused not only by the flexural deformation associated with shrinkage and creep of concrete, but also by the propagation of diagonal shear cracks which lead to out-of-plane displacement. It is assumed that the diagonal shear crack gradually extends for about 30 years, accompanying the top slab deflection.

From the finger-touching examination of the crack and elastic wave reflection test, the diagonal shear crack seems to be formed at many places in the culvert. At this moment, they are formed locally, and not fully linked along the culvert axis. Because the vertical load on the diagonal crack position can be redistributed along the culvert axis by the three-dimensional effect, the safety of the culvert can be maintained even though the diagonal crack is locally formed. Detailed coupled analysis of the whole structures and soil foundation under static and dynamic conditions will be needed for upgrading the maintenance strategy of existing infrastructures.
